Article

Assessment of Overheating Risk in Gynaecology Scanning Rooms during Near-Heatwave Conditions: A Case Study of the Royal Berkshire Hospital in the UK

Hannah Gough ^{1,*} , Samuel Faulknall-Mills ², Marco-Felipe King ³ and Zhiwen Luo ⁴

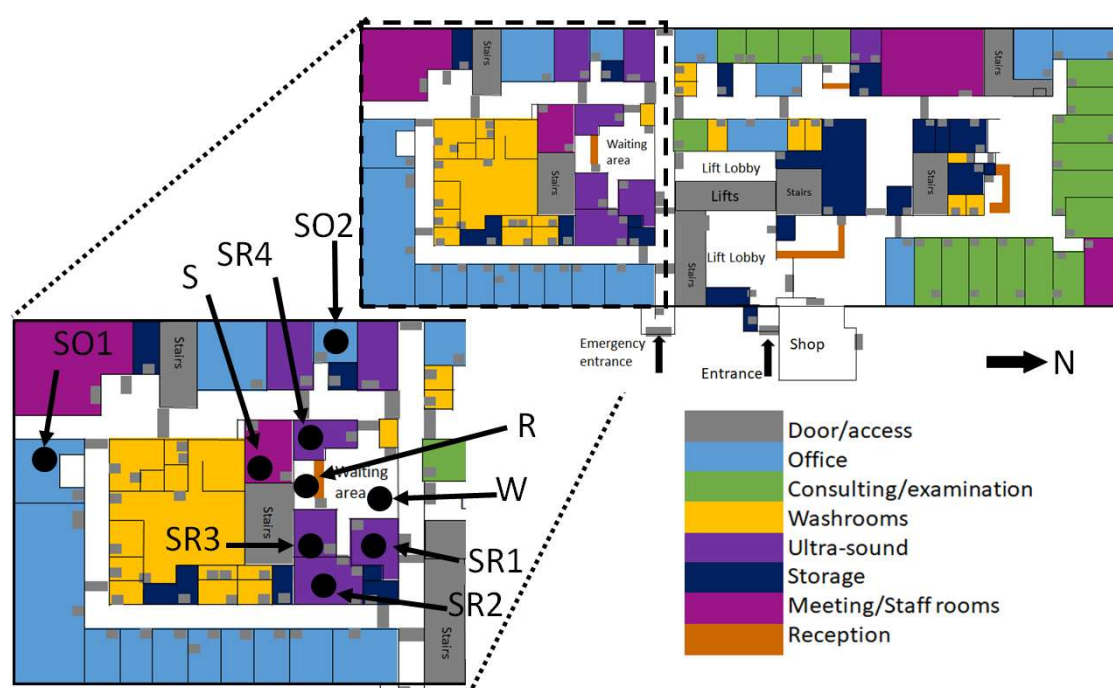
Figure 2. Floor plan of level 2 of the Maternity and Gynaecology building, colour coded by room use. Total area: 2162.52 m². Cutaway shows the focus area of the study and the symbols for sensors and locations are described in Table 1. The map is based on building plans provided by RBH.

The focus area of the study was the waiting/reception area (capacity: 20–30 people) and staff break room (capacity: 10 people) associated with the ultrasound scanning rooms (6 rooms, 4 sealed, 2 naturally ventilated) on Level 2, the ground floor (Figures 1 and 2). The only rooms with windows are the ones directly connected to the building façade, in this case, the two staff offices (Figure 2, marked as SO1, SO2 respectively). Only the scanning rooms without direct natural ventilation (four) are monitored. These are positioned within the centre of the building (Figure 2). Room 3 (Marked as Sensor SR3) has air-conditioning available to use, with a portable air-conditioning unit also being deployed (unknown date of deployment and operation times) in the waiting room in front of the reception desk (Figure 2). Sensor naming convention is shown in Figure 2. Occupants of these areas include admin, cleaning, and clinical staff (all day), patients and pregnant patients (<5 h stay), all of whom will be negatively affected by high indoor temperatures [40]. Varying environmental conditions have also been reported across the entire floor and building (Figure 2).

Natural ventilation is not a viable solution in this area of the RBH, due to the central position of the at-risk scanning rooms within the building (Figure 2). Also, within heatwave conditions, it is expected that air-pollution also increases, adversely affecting those with respiratory conditions [18]. Refs. [24,45,46] highlight that there are few examples of innovative natural ventilation/passive cooling strategies being used in hospital buildings, due to risk-adverse procurement and tight budget constraints. Noise may also prevent windows and doors from being opened. Whilst this study has focused on temperature, other factors, such as airflow, moisture, and odour also influence thermal comfort and may also need to be considered for specific patient groups. Other more complex ventilation solutions are described in [45].

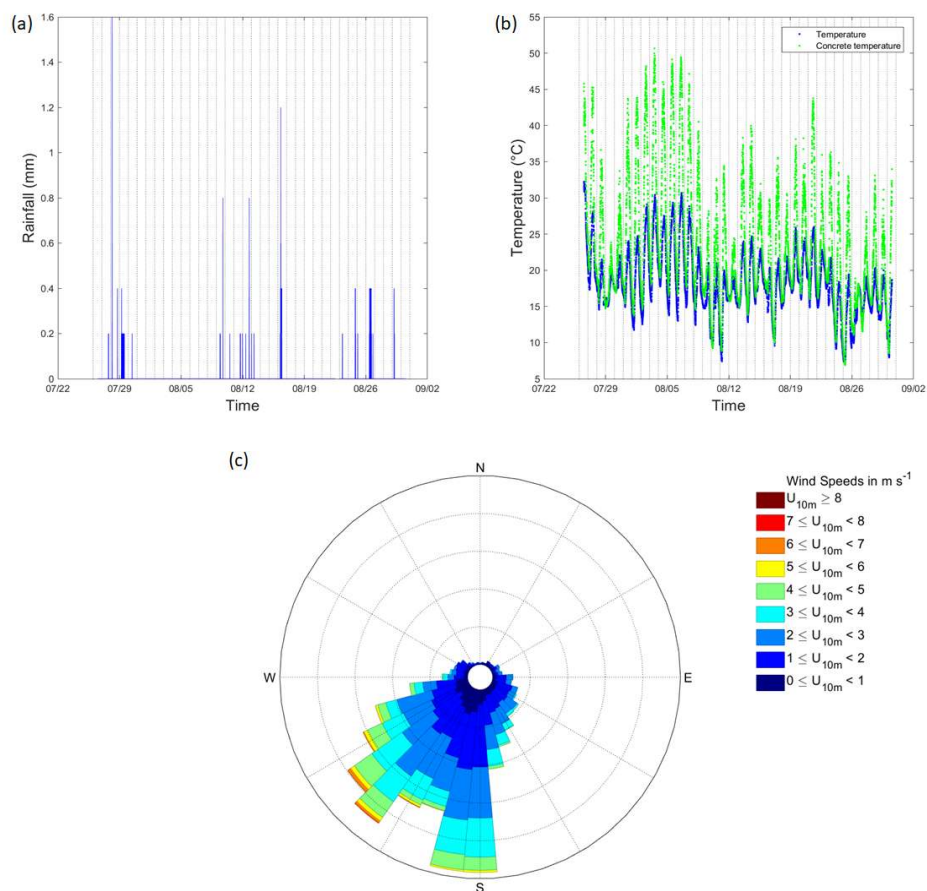
Figure 5. Observations from UoRAO for the study period. (a) rainfall, (b) temperature and concrete temperature, and (c) wind direction and 5-min wind speed at 10 m (meteorological standard). Vertical grey lines denote midnight of each day.

Reference external temperatures were measured at the University of Reading's Atmospheric Observatory (UoRAO), also at five-minute intervals as part of the automated system (accuracy: 0.1 °C). The temperature of concrete was also logged. The climate conditions of Reading can be classed as temperate. UoRAO is approximately 1.5 km as the crow flies from the Maternity and Gynaecology building (Figure 4). For details on the experimental set up of the UoRAO and measurements available see [41]. Whilst this distance is small, the external temperatures around the hospital site may be slightly warmer due to the urban heat island effect. Figure 5 details the background weather conditions throughout the campaign, with little rain being recorded (Figure 5a). Low wind speeds (95 % were $<6 \text{ m s}^{-1}$) were recorded throughout the study period and for most of the study period, the wind direction remained within the prevailing sector for the area (Figure 5c).

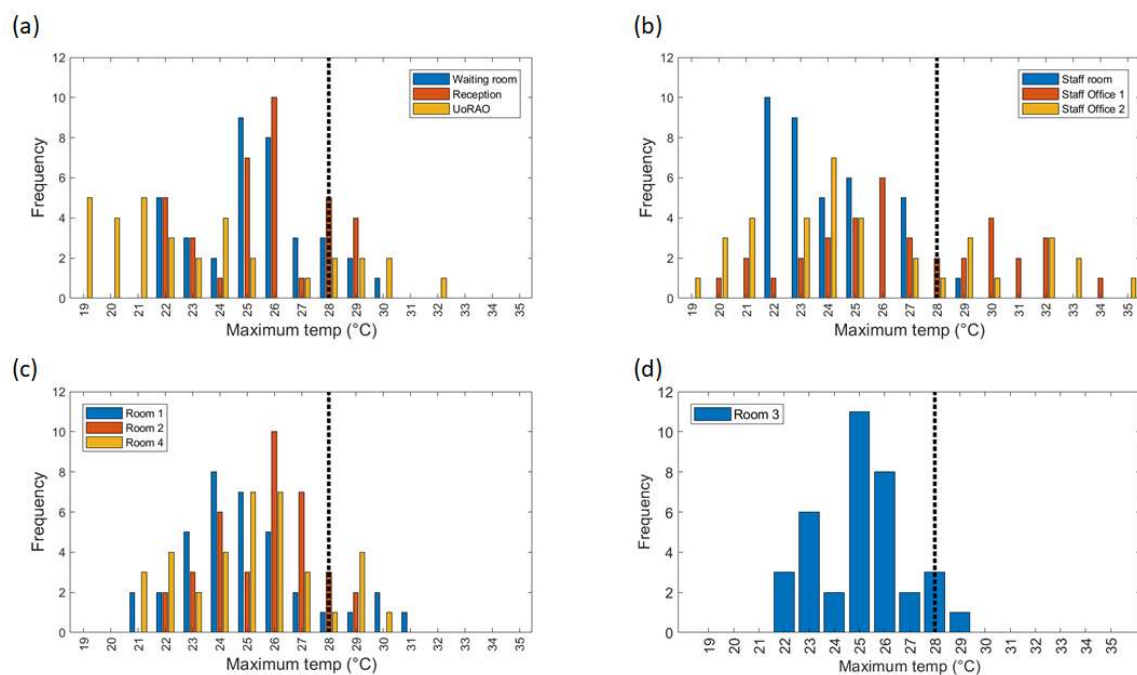
Figure 9. Maximum daily temperatures recorded in all rooms across all weekday measurements. For clarity, similar rooms are plotted on one subplot (a) Waiting room, Reception and the observatory (UoRAO), (b) Staff room and Staff offices, (c) Room 1, 2, 4 and (d) Room 3. All plots have the same axis. The vertical dashed line denotes an upper threshold of 28 °C.
